# ASTON

## LANE COVE

PROJECT UPDATE  
19<sup>th</sup> November 2014

**Construction Update:**

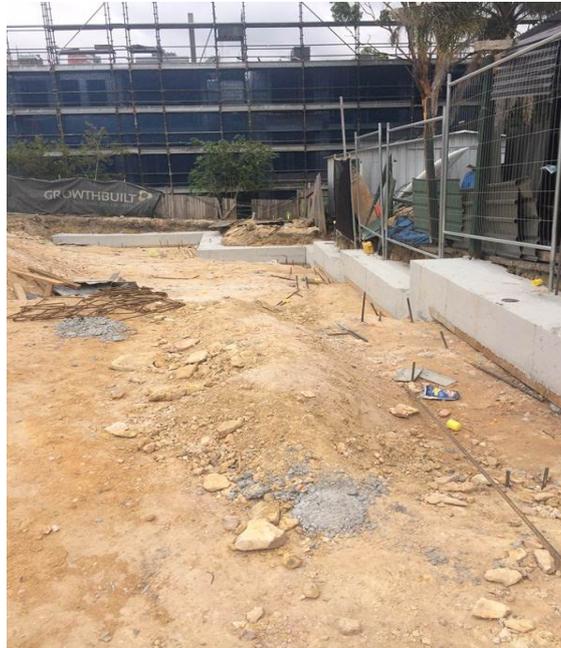
Photo 1: The capping beam to the western and south west corner has been poured and stripped. This capping beam has been poured of the 18 piers which were shown in the previous report

The capping beam and anchors are completed to the western boundary and the first row of anchors are installed. Once these anchors have been tensioned they will continue on bulking out the second level.

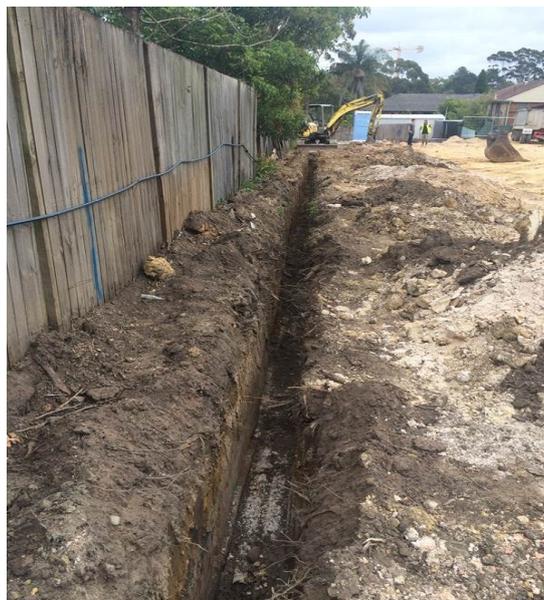
Photo 2: The sewer diversion works to the rear of the property have been excavated and the pipes have now been laid. The sewer inspection and final connection is being carried out this Friday.

The sewer diversion works are almost completed. The main replacement line has been installed and the connection at each end is awaiting inspection on Friday 21<sup>st</sup> November. Once Sydney Water has approved this work the connections will be completed and the existing sewer removed.

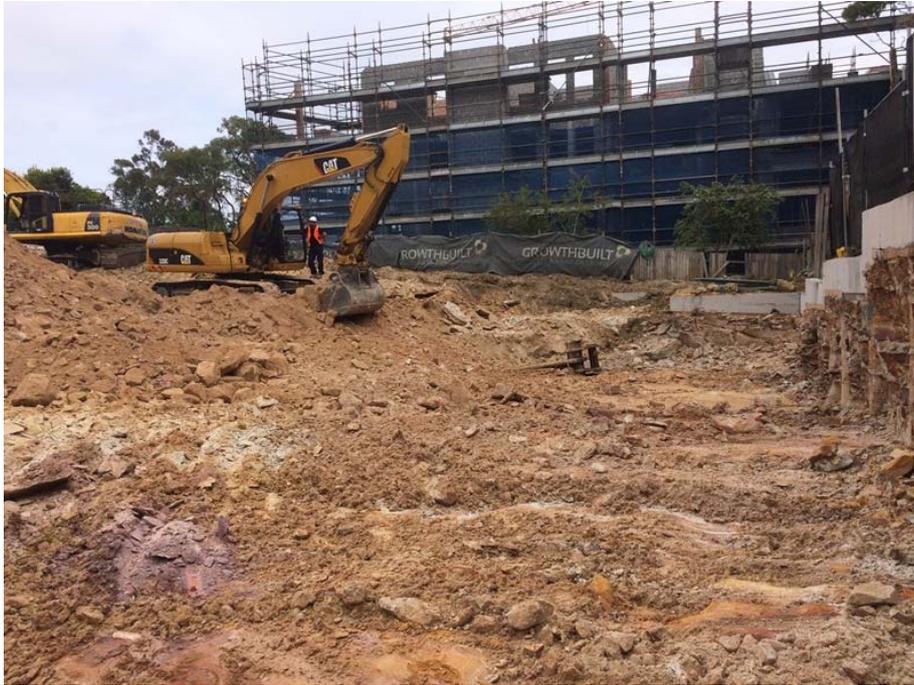
Photo 3: This photo shows that the earthworks have commenced. The material which is currently being removed is medium sandstone with a small amount of clay.

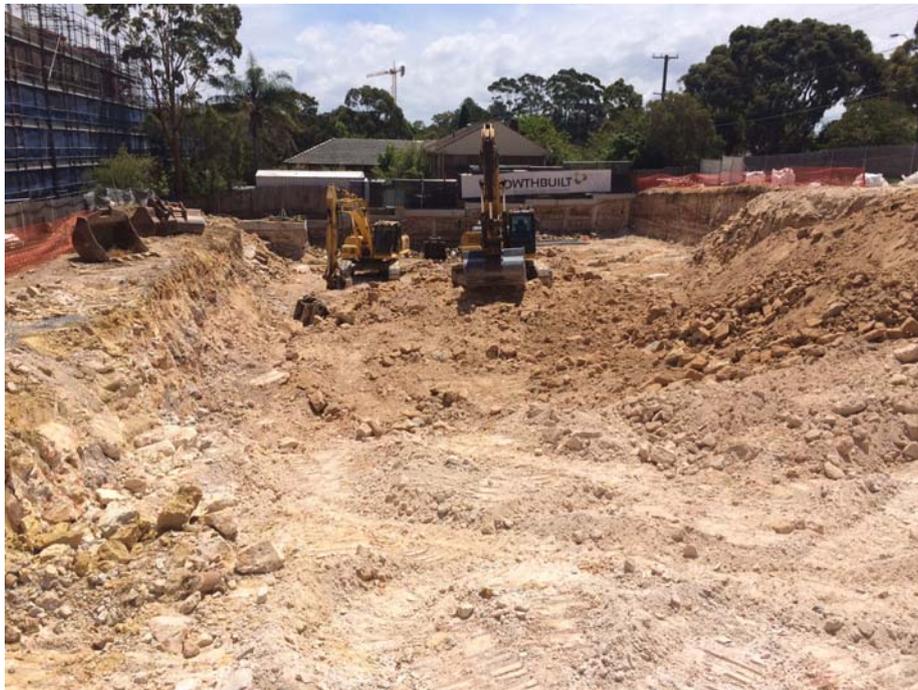
Photo 4: This photo was taken on the 19<sup>th</sup> November and shows that the first level basement has almost been excavated and removed. The bulk earthworks are approximately 40% complete. The first row of anchors has been drilled and needs to be grouted.

The bulk earthworks are approximately 40% completed to the site. On average approximately 2.5m to the entire site has been removed.

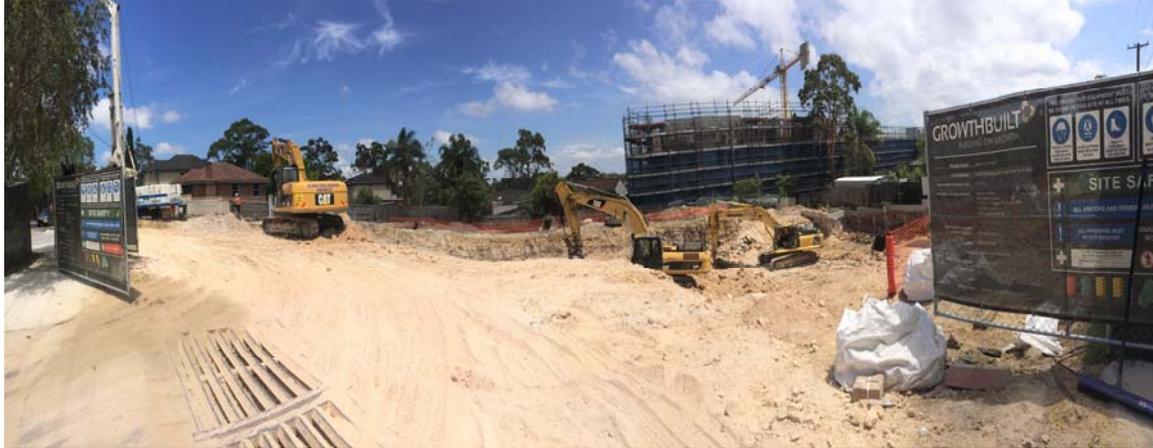
Photo 5: This photo is an overall picture of the entire site, you can see the two excavators removing the material within the hole and one machine is loading truck for the removal. The piling rig is currently in the corner of the site as there are approximately 10 more piers to be installed to the front of the site once the bulk earthworks are almost completed.

The piers and crane base will be completed on the 20<sup>th</sup> November so it has time to cure prior to the delivery of the crane. This takes approximately 28 days to cure.
